PANAMA FLATS CONCEPT PLAN

Prepared for:
**District of Saanich
Parks Department**
(RFP No. 44/12)

Prepared by:
LADR Landscape Architects Inc.

February 17, 2014

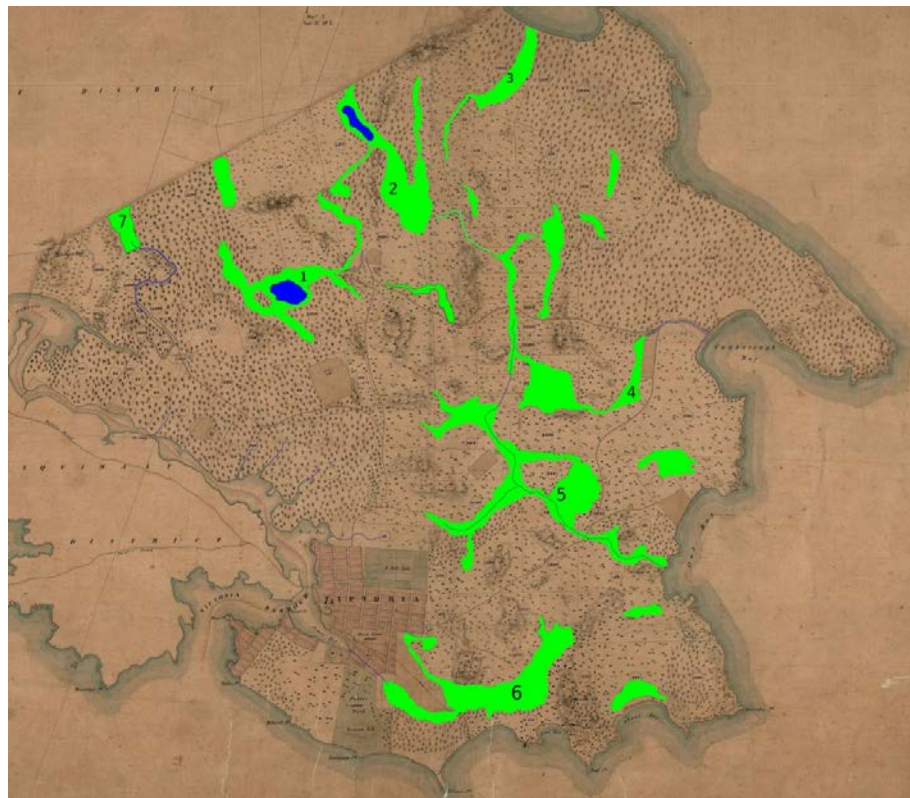
Map 3: Victoria Official map, 1858, with Wetlands & Riparian Corridors Highlighted. #7 is Panama Flats

The entire study area, with minor exceptions, was cleared and put under cultivation between 1858 and 1926 (see Map 3 below). In the 1960's and 70's areas in the north around Panama Hill were removed from agricultural production and trees, shrubs and grasses (primarily non-native invasive species) began to recolonize. The south, central and eastern portions of the site remained cultivated until 2008.

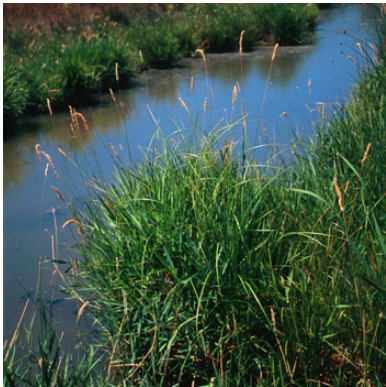
Reed Canarygrass

Reed canarygrass is a tall, rhizomatous grass that dominates all areas that are seasonally wet and have been left fallow for long periods. It is rapidly spreading into areas recently abandoned and eventually may occupy all but the deepest portions of the wetland. This will significantly reduce habitat for Vancouver Island beggarticks and many birds. It is also spreading into moister portions of the uplands. No large-scale reed canarygrass control has ever been attempted in Canada. In other jurisdictions, reed canarygrass has been controlled with herbicide. It is believed to be sensitive to tilling or repeated mowing. Reed canarygrass has high light requirements and is outcompeted by taller woody vegetation.

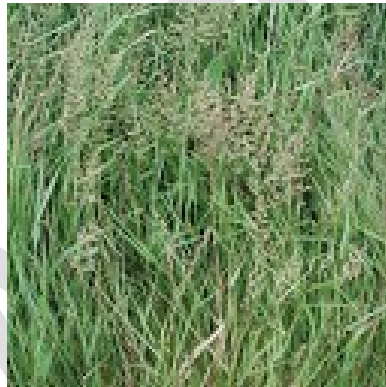
Bentgrass

Bentgrasses are well established throughout all open areas in the project area that are not dominated by reed canarygrass. Some species (especially creeping bentgrass) are highly tolerant of flooding and are rapidly colonizing the

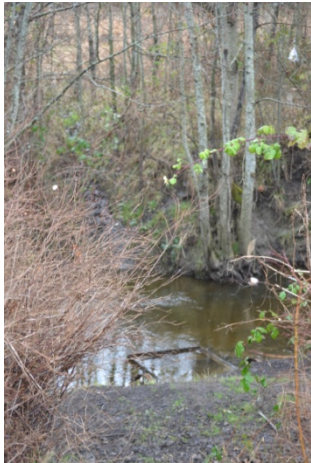
Colquitz River adjacent Panama Flats, February, 2013

Colquitz River is a salmon bearing channel that has been altered by past agricultural land uses, increased runoff from impervious surfaces on adjacent urban development, and loss of upstream hydrological storage capacity. Its existing condition is described in detail in the 2009 *Colquitz River Watershed Proper Functioning Condition Assessment*. The report states, among other things, that Panama Flats floods annually in winter due to overflow from the Colquitz River which, in the reach adjacent the Flats, has been reduced to a ditch along Interurban Road. The report states “although high flows access the field as a floodplain, this only occurs in the wettest months, and is a result of increased peak flows from the surrounding effective impervious areas (EIA) in the watershed. If the channel had its historic shape and depth, it would flood more frequently and reduce the erosive forces in the channel. Not surprisingly, the stream banks in this reach are visibly eroding and slumping. This reach has been classified as Non-functional due to its ditch-like characteristics, inappropriate shape to handle high flows, and active erosion throughout.”⁵

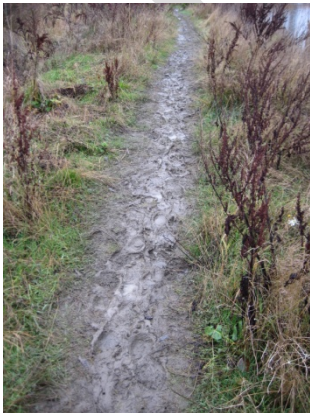
Additional recreational activities within the study area include picnicking, playing in Panama Hill Park, skating on the Flats when winter temperatures are cold enough, jogging, walking and blackberry picking. Paths along the top of the berms are not formally developed trails, and are discontinuous in winter months. Nevertheless they are used by pedestrians throughout the year. Small temporary bike jumps are occasionally set up in the bush at the south end of the site (south of the watercourse), and have also been seen adjacent the berm on the east side of the site.

Unofficial Trails on Perimeter Berm

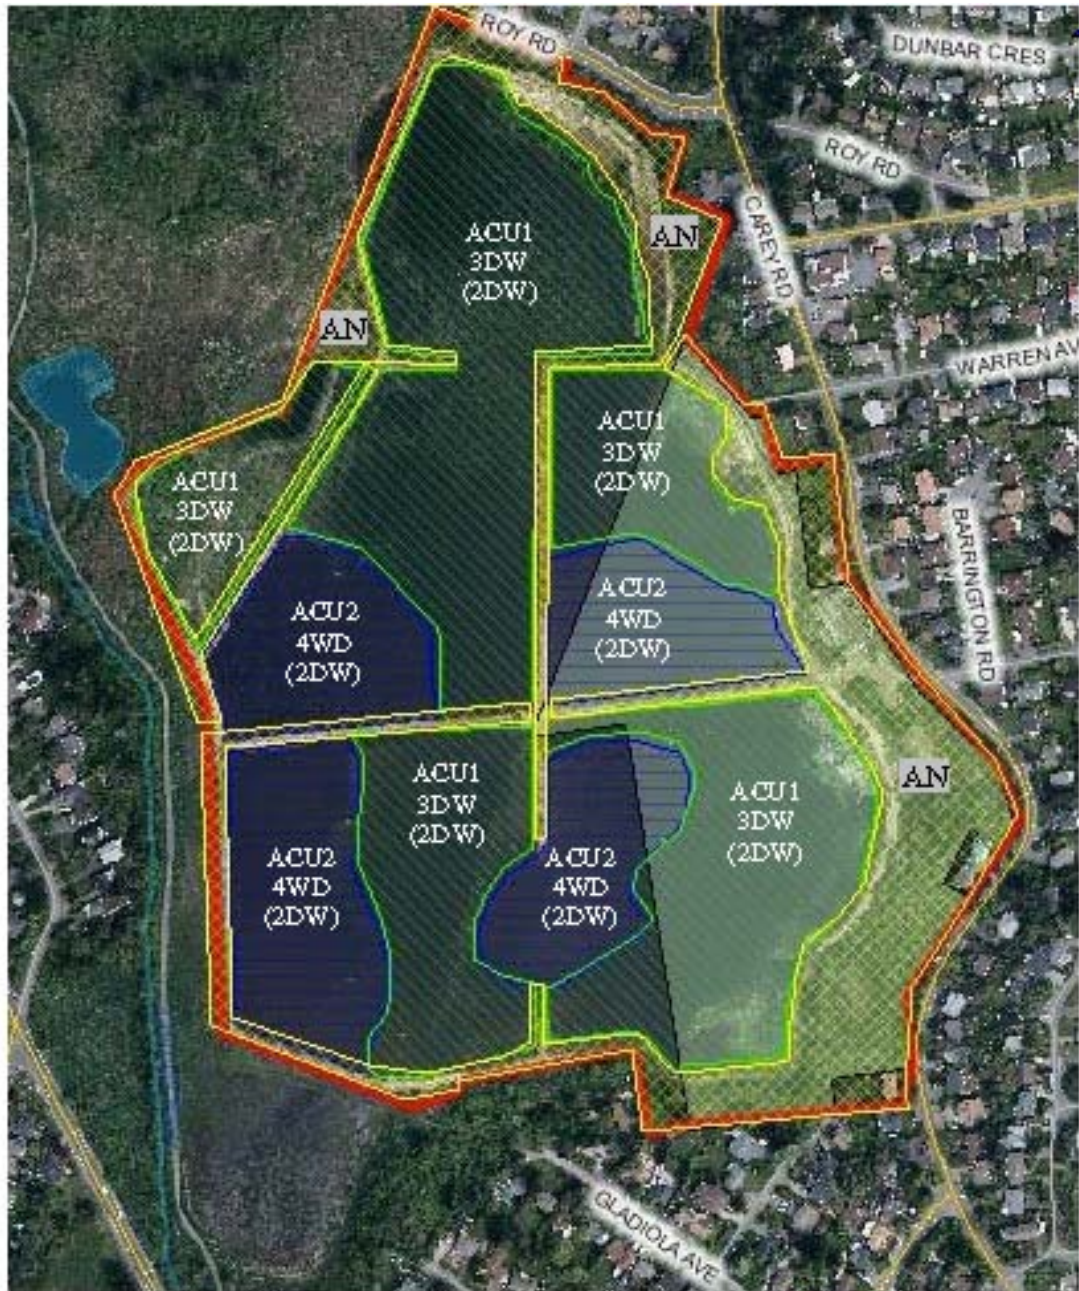
- Subject Property
- Agricultural Land Reserve
