Prospect Lake Road Traffic Operations and In- Service Road Safety Review

Final Report

July 10, 2020

Submitted to: District of Saanich.
Prepared by McElhanney Ltd.

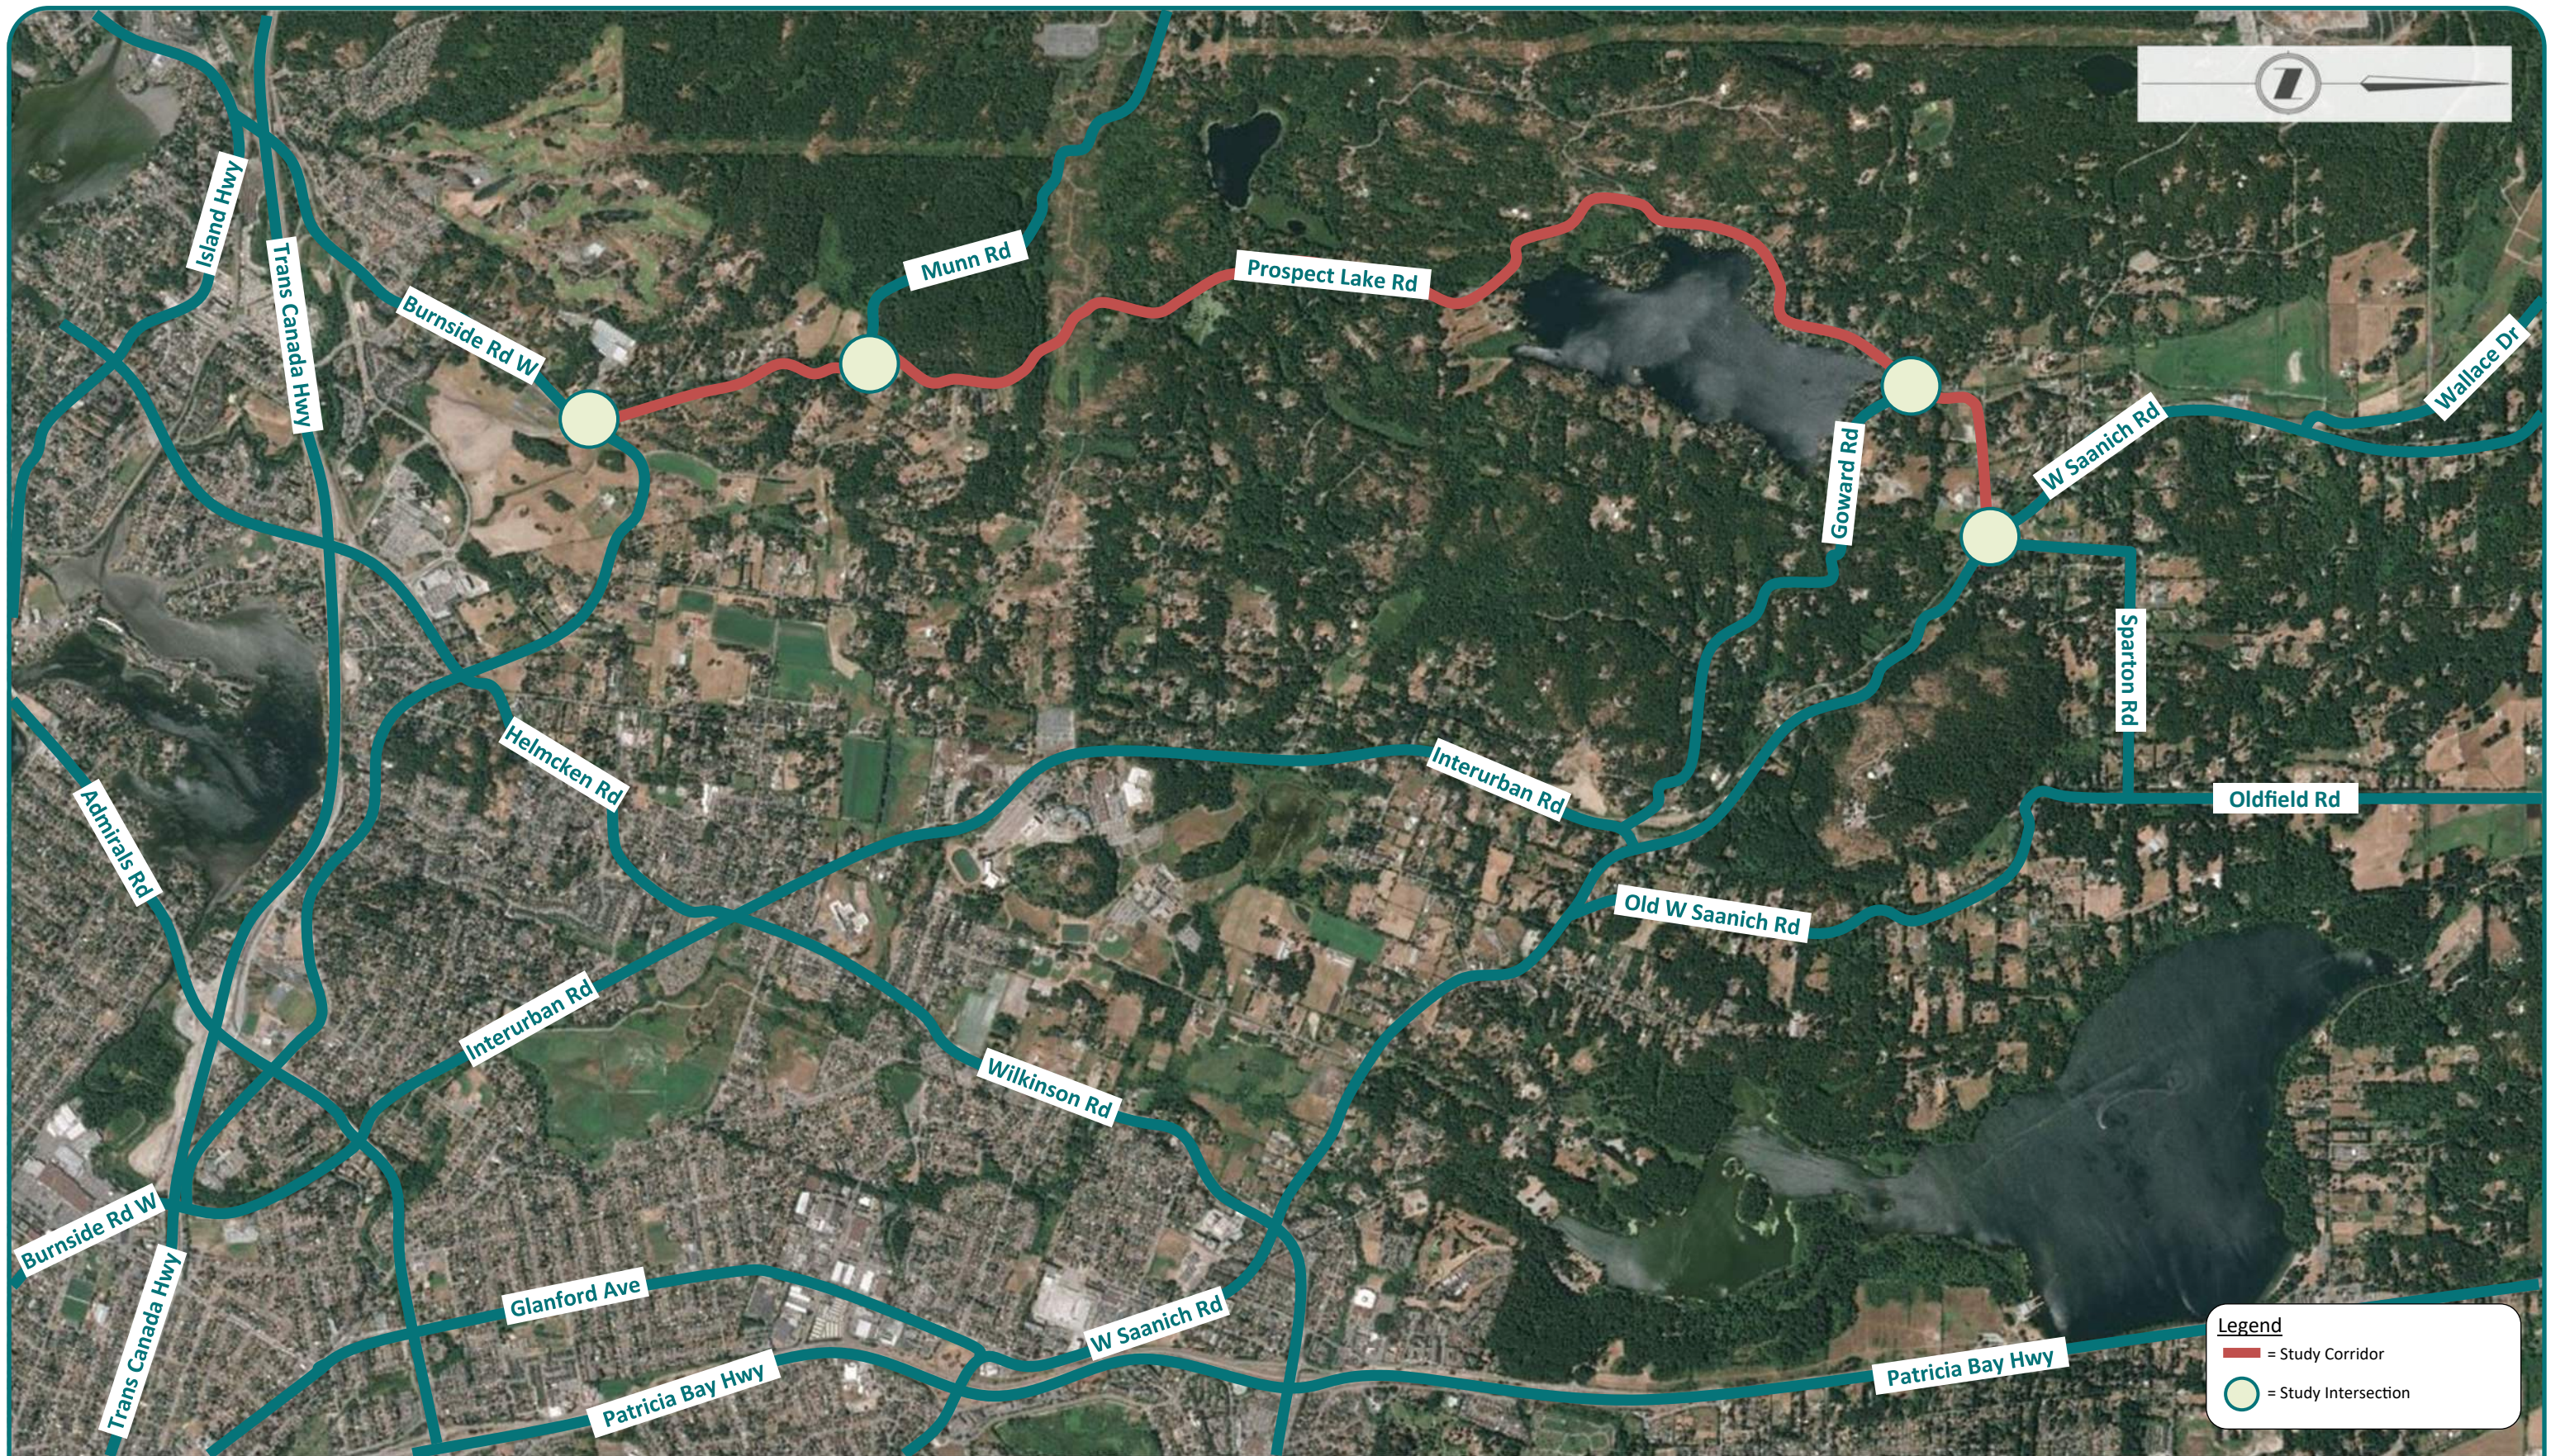
Project Location

For the most part, the corridor serves as an access point for single family homes within the study area. Prospect Lake Elementary school and several parks are also situated along the corridor. As shown in **FIGURE 1**, Prospect Lake Road is a parallel route to other corridors located to the east, such as Interurban Road, West Saanich Road, and Highway 17 (Patricia Bay Highway). A connection to the Trans Canada Highway to the south is also provided via West Burnside Road.

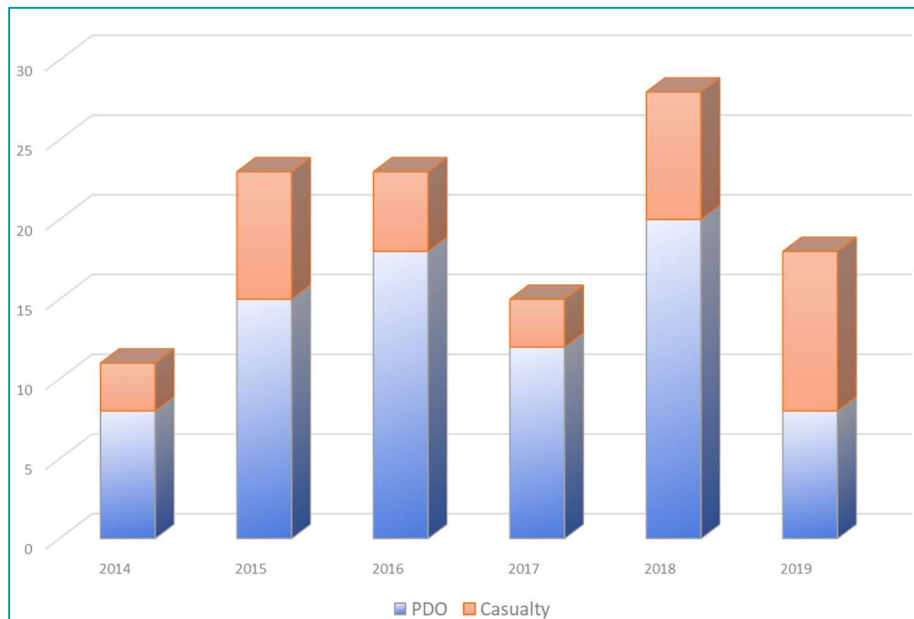
Figure 3 – ICBC Claims by Severity (January 2014 through December 2019)

A summary of the ICBC claims data by year and severity is presented in **FIGURE 3**. **Note that “casualty” claims represent collisions that involved injuries and/or fatalities while “PDO” represent property damage only claims.** On average, there are approximately 20 claims made per year along Prospect Lake Road.

Note: Casualty claims includes collision resulting in injuries and/or fatalities

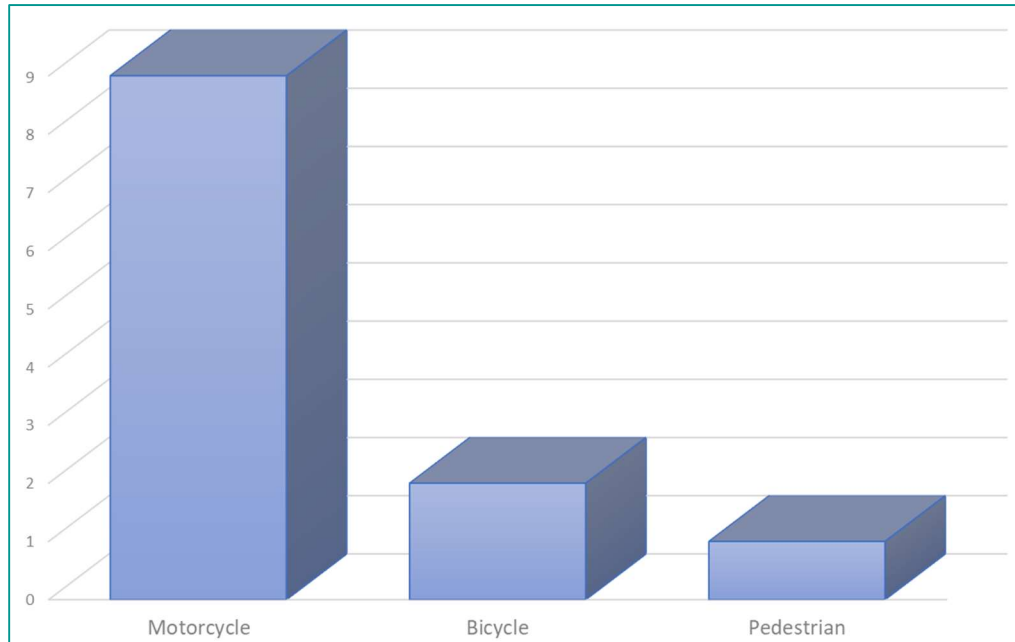
Figure 4 – ICBC Claims by Vulnerable Road Users (January 2014 through December 2019)

FIGURE 4 includes the claims that involved vulnerable road users. It is noted that Prospect Lake Road is a popular route for motorcycles and a designated cycling route. Over the six-year period, there were nine collisions that involved motorcycles and two claims that involved cyclists. However, there could be additional near misses that occurred but were not recorded by ICBC as claims were not made. There was also one collision that involved a pedestrian.

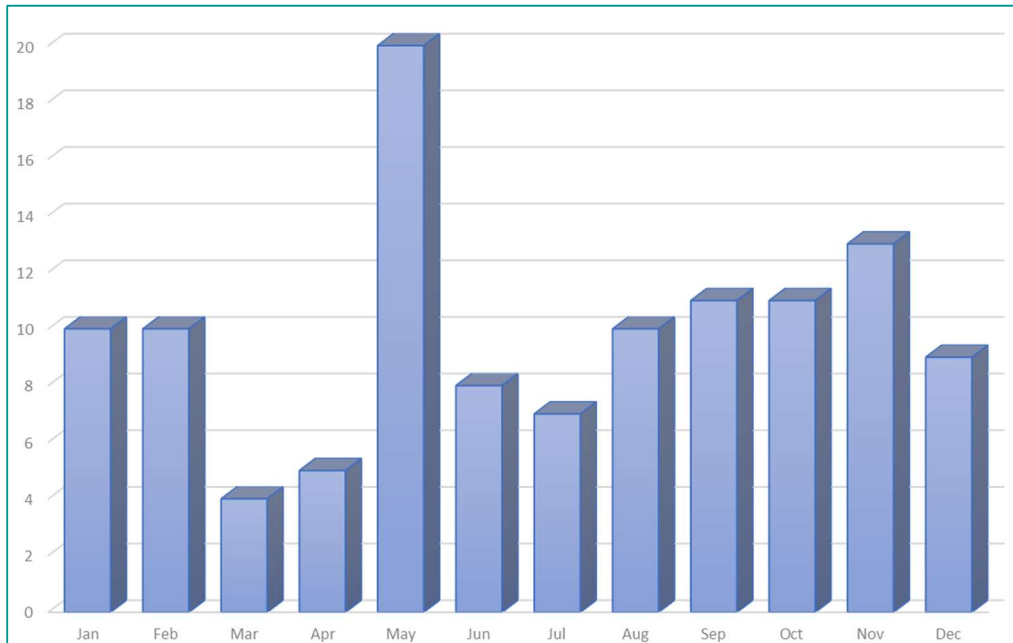
Figure 5 – ICBC Claims by Month (January 2014 through December 2019)

Collision trends by month and time of day are presented in **FIGURE 5** and **FIGURE 6**, respectively. Approximately 17% of all claims occurred in May, while 7.5% occurred in March and April combined. All other months were consistent with approximately 8.5% of the claims, on average. It is not clear based on the data why there was a spike in collisions in May, but this could be a result of changing weather patterns. The weather starts to become clearer in May and daylight hours start to increase. This may lead drivers to believe that they can drive faster along the corridor when the actual road conditions may not be suitable for this.

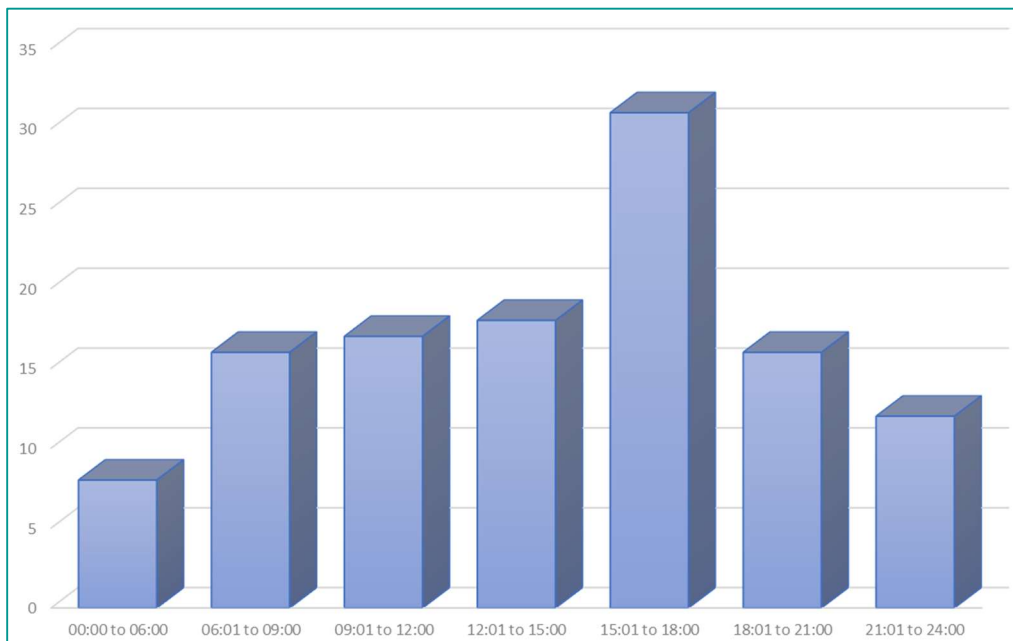
Figure 6 – ICBC Claims by Time of Day (January 2014 through December 2019)

Approximately 25% of claims were made during the PM peak period from 3:01 to 6:00 PM, which was more than 10% higher than the AM peak period (14% occurred between 6:01 to 9:00 AM). This is not a surprise, as the PM peak volumes along Prospect Lake Road are nearly double those during the AM peak period.

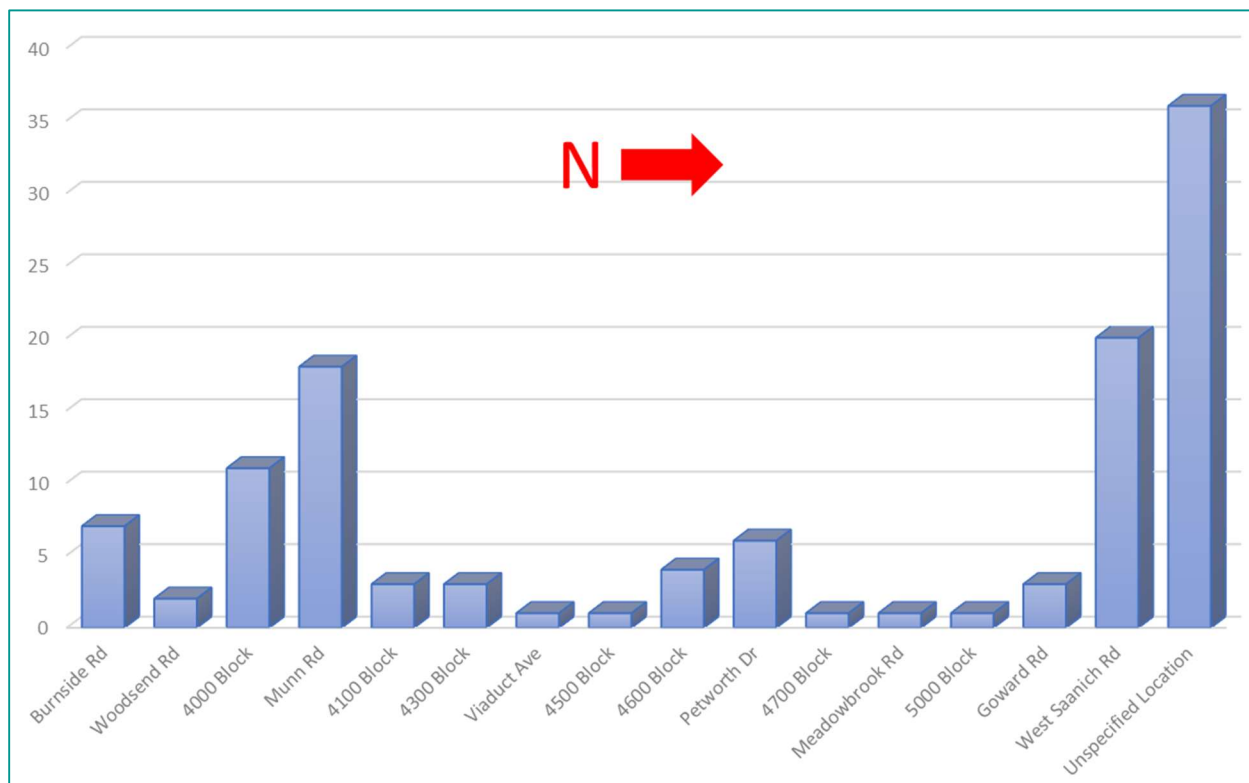
Figure 7 – ICBC Claims by Location (January 2014 through December 2019)

A summary of the claim data by location is presented in **FIGURE 7**. Approximately 50% of the claims were recorded at or near intersections while 20% were recorded along segments of Prospect Lake Road. The remaining 30% of claims had unspecified locations. The majority of claims at intersections occurred at the four study intersections, with the highest occurring at Prospect Lake Road / West Saanich Road / Sparton Road (17% of all claims). Approximately 33% of the claims occurred along a 1.2 km stretch of the corridor in the south between West Burnside Road and Munn Road. The several vertical/horizontal

curves in this area combined with the skew angle of the Prospect Lake Road / Munn Road intersection likely contribute to higher number of collisions along this segment.

Note: The claims assigned to an intersection may have occurred near to, but not at, the intersection

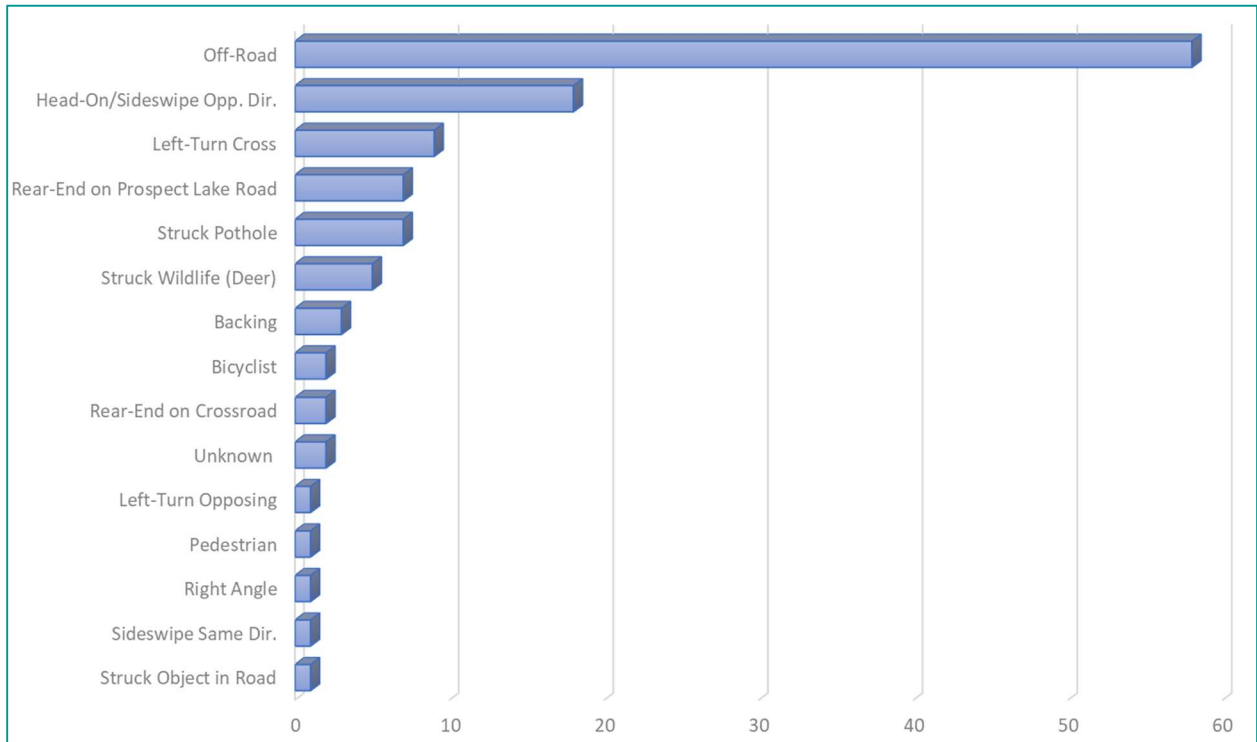
Figure 8 – ICBC Claims by Collision Type (January 2014 through December 2019)

FIGURE 8 presents the claims data for Prospect Lake Road based on the collision type. Almost 50% of all claims were a result of off-road collisions while the second highest collision type was head-on/sideswipe opposite direction (15% of all claims). The narrow cross-section of the roadway combined with winding curvature are likely key contributors to these types of collisions. Intersection related collisions (e.g. rear-end, left-turn cross, etc.) accounted for approximately 17% of the collisions along the corridor. Given that 50% of collisions were recorded at or near intersection (refer to **FIGURE 7**), it is likely that the majority of these collisions occurred approaching or exiting the intersection.

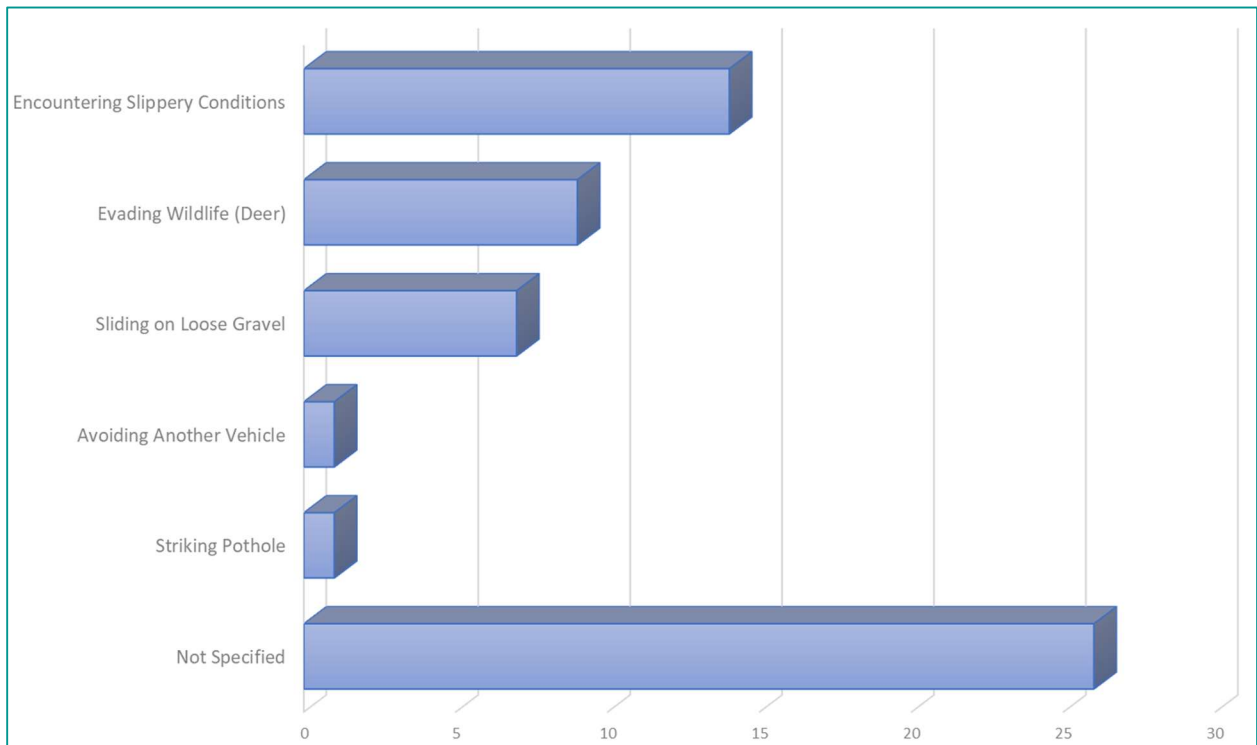
Figure 9 – Cause of Off-Road Collision Claims (January 2014 through December 2019)

As off-road collisions are a significant occurrence along the corridor, a further breakdown of these types of collisions is provided in **FIGURE 9**. Of the off-road claims that were made, 25% were due to slippery conditions while 17% were a result of evading wildlife or other vehicles. This further suggests that the narrow cross-section of Prospect Lake Road with minimal to no shoulders contributes to these types of collisions. Although the ICBC data is inconclusive, data provided by Saanich Police indicates that excessive speeds and/or driver error likely contribute to off-road collisions.

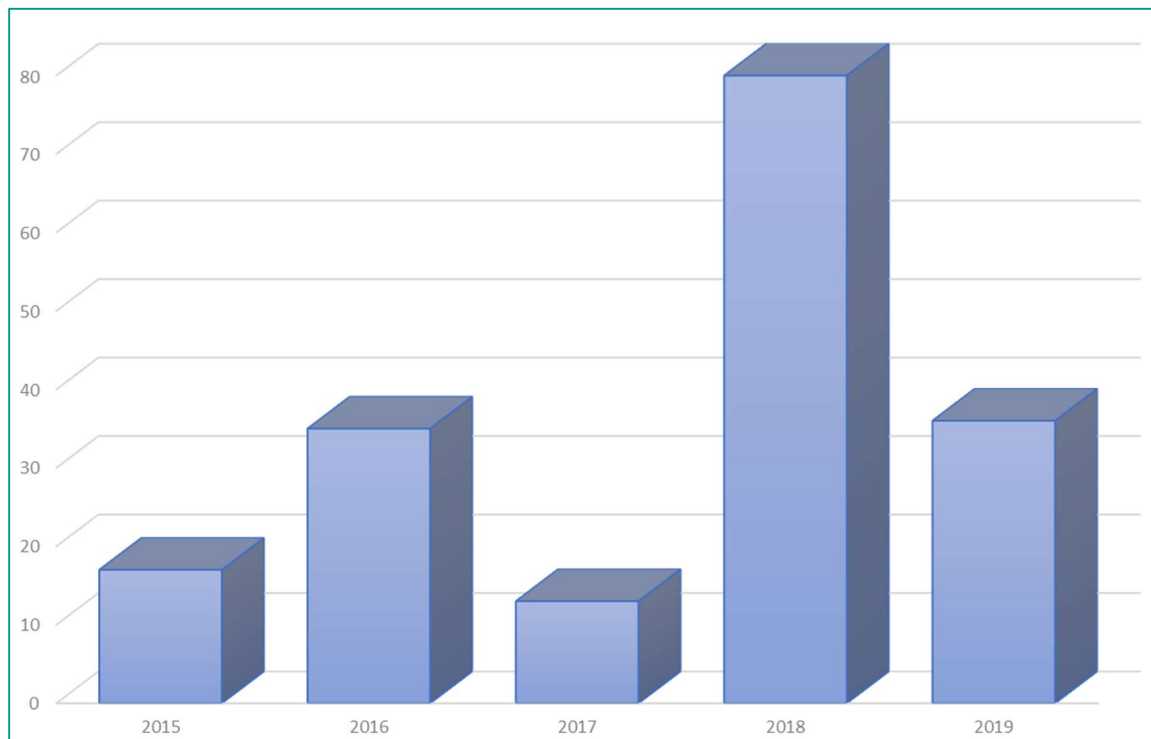
Figure 10 – Saanich Police Violation Tickets by Year (January 2015 to February 2020)

The District also provided information regarding Saanich Police violation tickets that were issued to motorists on Prospect Lake Road from January 2015 to February 2020. Summaries of the violations by year and location are provided in **FIGURE 10** and **FIGURE 11**, respectively. Of the 181 violations that were issued over the five-year period, 80 were issued in 2018 alone. In addition, over 90% of violations were issued in a 1.5 km section of Prospect Lake Road from south of Meadowbrook Road to West Saanich Road. This is likely a result of increased enforcement in the north, particularly around the elementary school, and less opportunities for enforcement in the south (e.g. limited locations where police can pull over to conduct radar enforcement, etc.).

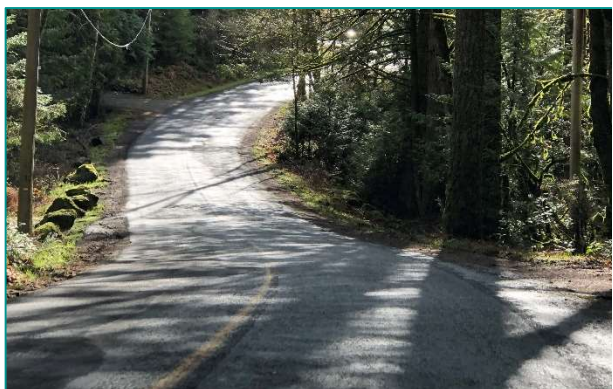
Photo 1 – Horizontal and Vertical Curve

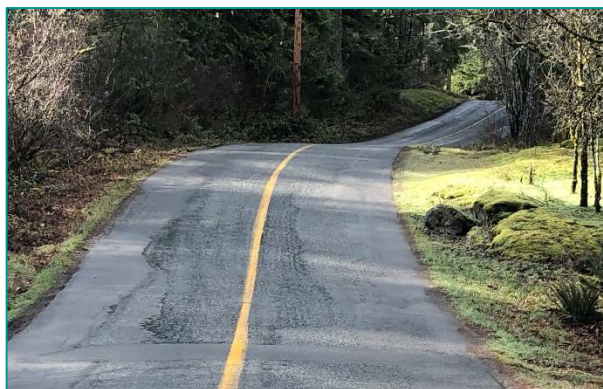
Photo 2 – Crest Curve into Horizontal Curve

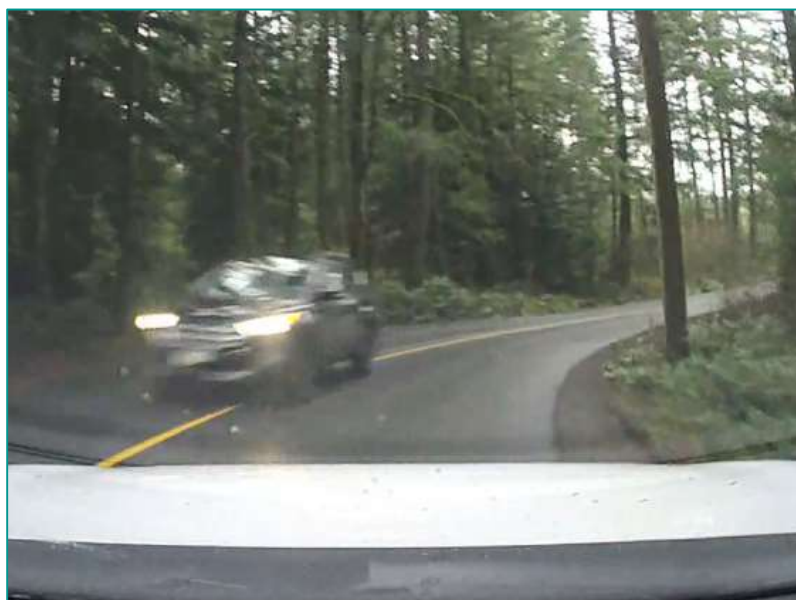
Photo 3 – Near Miss Incident With Cross-Over Vehicle

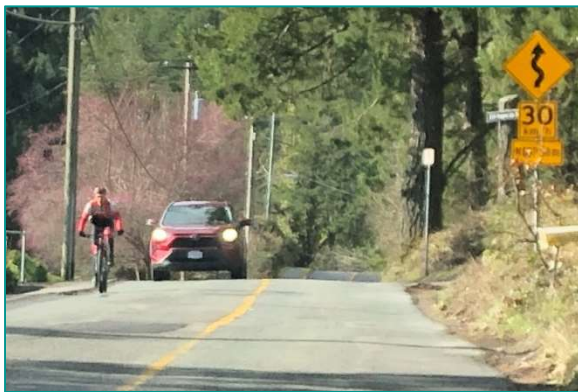
Photo 4 – Northbound Cyclist Near North End

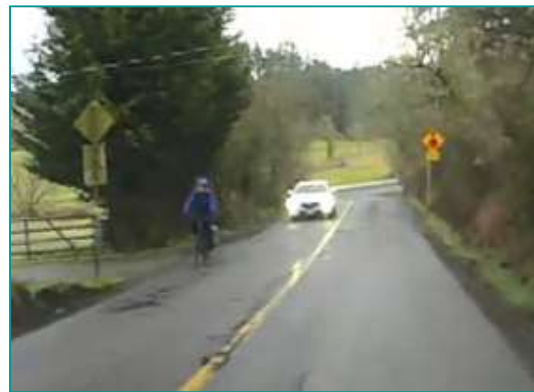
Photo 5 – Northbound Cyclist Near South End

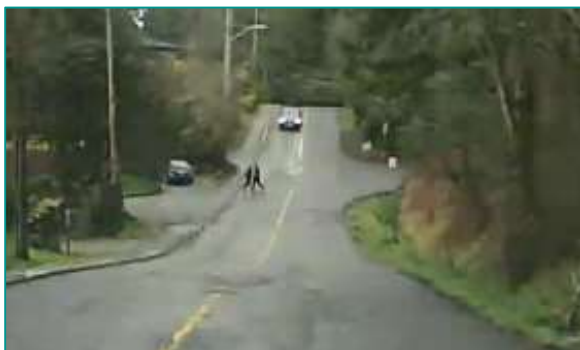
During the corridor drive throughs, minimal pedestrian activity was observed. However, pedestrians were seen using the sidewalk along the eastern side of Prospect Lake Road, often north of Prospect Avenue. On one occasion, two pedestrians were observed crossing Prospect Lake Road at Meadowbrook Road (refer to **PHOTO 6**). Although vertical curves are located north and south of this intersection, the approach is relatively straight and sight lines were adequate for us to identify that pedestrians were crossing the road. Community mailboxes are located at this intersection, which likely results in an increase in pedestrian activity in this area.

Photo 6 – Pedestrians Crossing Prospect Lake Road at Meadowbrook Road

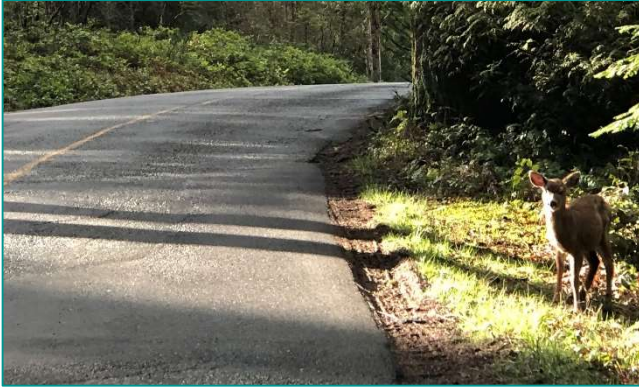
Deer were also observed during the site visits, as shown in **PHOTO 7** and **PHOTO 8**. During the nighttime drive through (**PHOTO 8**), we encountered a deer on the side of the road which was difficult to see until it was directly in front of our vehicle.

Photo 7 – Wildlife during the Daytime

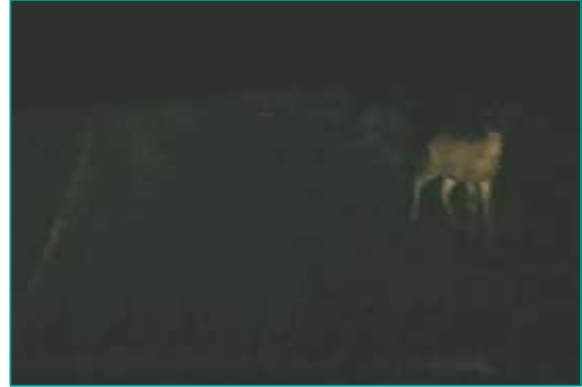
Photo 8 – Wildlife during the Nighttime

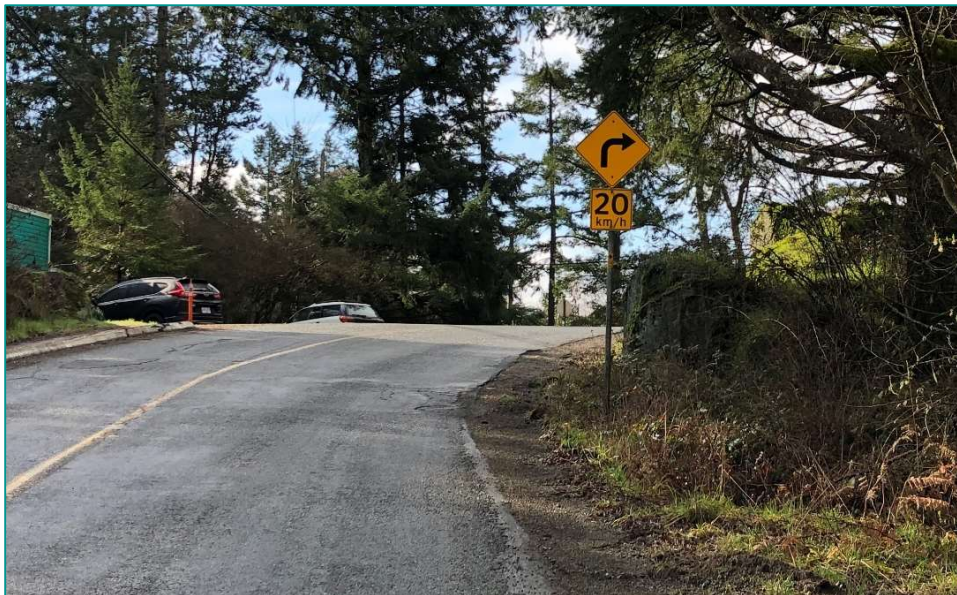
Just south of Goward Road, there is a combined horizontal and vertical curve in the roadway alignment with limited visibility for both drivers travelling on Prospect Lake Road and waiting at the stop bar on Goward Road. **PHOTO 9** shows the curved alignment of the corridor, which includes a 20 km/hr advisory speed sign. Further restricting the visibility at this location are the shrubs and rock outcrop located along the right side of the road edge. It is noted that the District has plans to remove the rock outcrop as part of the improvements currently under design for this section of the corridor.

Photo 9 – Southbound Prospect Lake Road, South of Goward Road

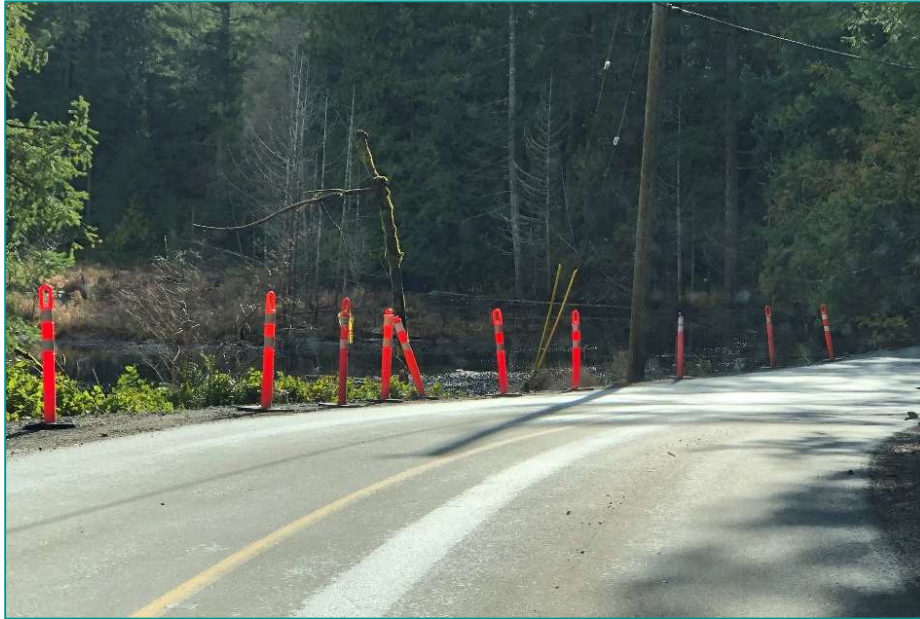
As southbound vehicles approach Trevlac Pond (north of Calvert Park), orange flexible delineator cones are located along the eastern road edge to indicate the potential hazard (refer to **PHOTO 10**). As you travel further to the south, Prospect Lake Road starts to climb a vertical curve which introduces a steep drop off on the eastern side of the road (refer to **PHOTO 11**). As noted previously, preliminary design is currently underway for the installation of road edge barrier in this location, which would reduce the risk of off-road collisions.

Photo 10 – Southbound Prospect Lake Road, Approaching Trevlac Pond

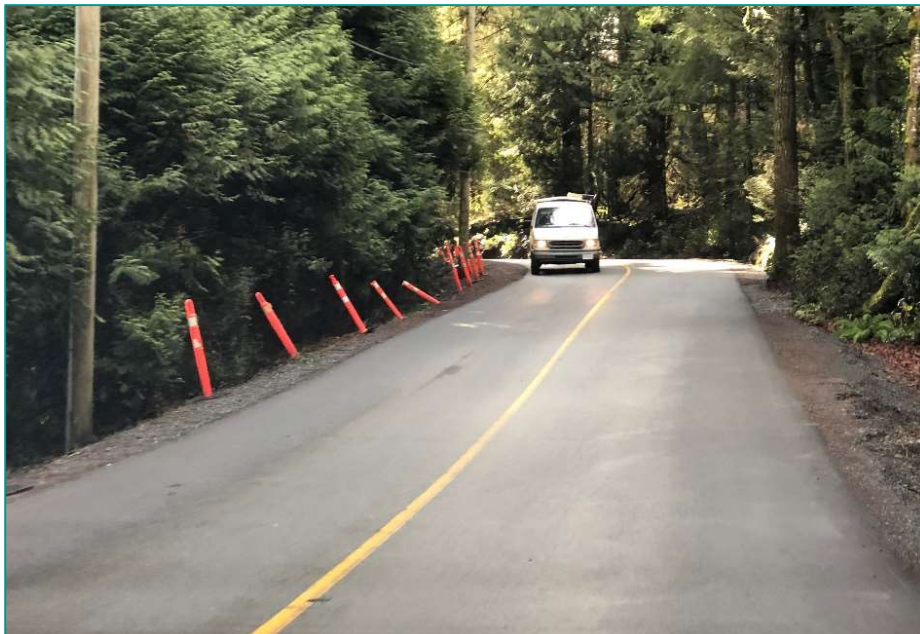
Photo 11 – Southbound Prospect Lake Road Near the Pond

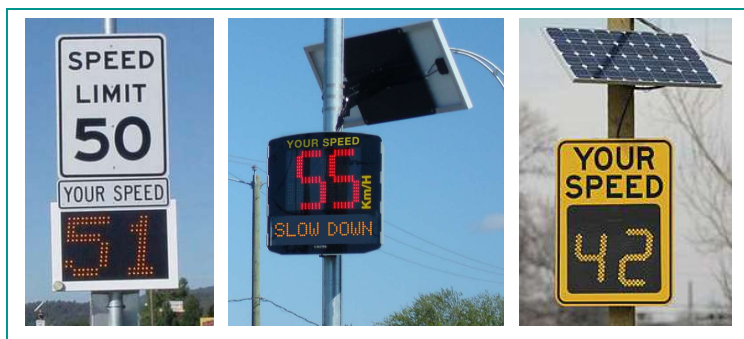
Figure 14 – Examples of Speed Reader Boards

The speed data that was provided suggests that corridor travel speeds (average and 85th percentile) are generally within the 50 km/hr posted speed limit for Prospect Lake Road. However, in areas with increased pedestrian/cyclist activity and/or higher density of driveway accesses, it might be desirable to reduce speeds in order to improve the safety of the roadway. This can be achieved through reduced posted speed zones, increased enforcement and potentially additional safe pullout locations for police, and the use of speed reader boards in high risk/high speed areas on tangents. Speed reader boards, examples of which are provided in **FIGURE 14**, can be used to tell drivers their current speed and whether or not they are travelling above the posted speed of the roadway. It is noted that speed reader boards are planned at Prospect Lake Elementary as part of the current design project for that section of Prospect Lake Road.

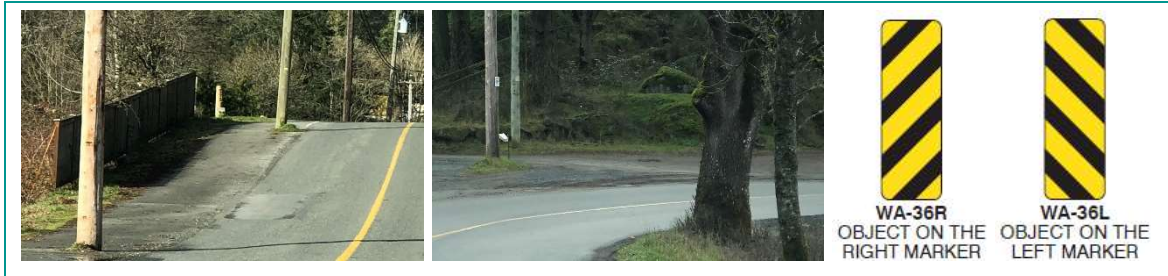
Figure 17 – Roadside Hazards / Object Markers

- Object markers can be placed on roadside hazards, such as trees and utility poles (refer to **FIGURE 17**). Since the corridor is generally without shoulders, object markers are recommended where hazards are within 1m from the pavement edge.

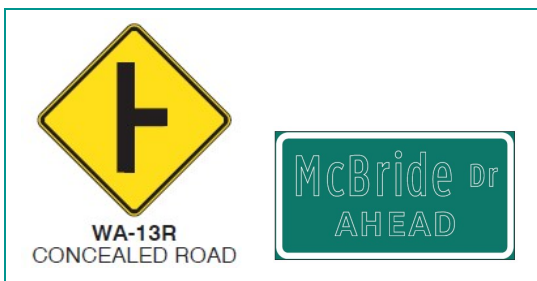
Figure 18 – Concealed Road Sign

- If feasible, consider removing/relocating large trees and utility poles that are along the road edge
- Improve the reflectivity of existing signage
- Trim bushes / rock outcrops to improve sight lines, particularly through curves in the roadway alignment
- Install additional lighting along the corridor
- Install regulatory speed signs at each end of and within the corridor to remind drivers of the expected speed
- Install intersection ahead signs (refer to **FIGURE 18**) with a street name tab (where appropriate) to warn motorists of hidden roadways, particularly at locations where the alignment of Prospect Lake Road curves in advance of an intersection
