PROJECT  
**3986 Telegraph Bay Rd, Saanich, BC**

SHEET TITLE  
 Replacement Tree Plan for  
 Site Servicing & Build-out

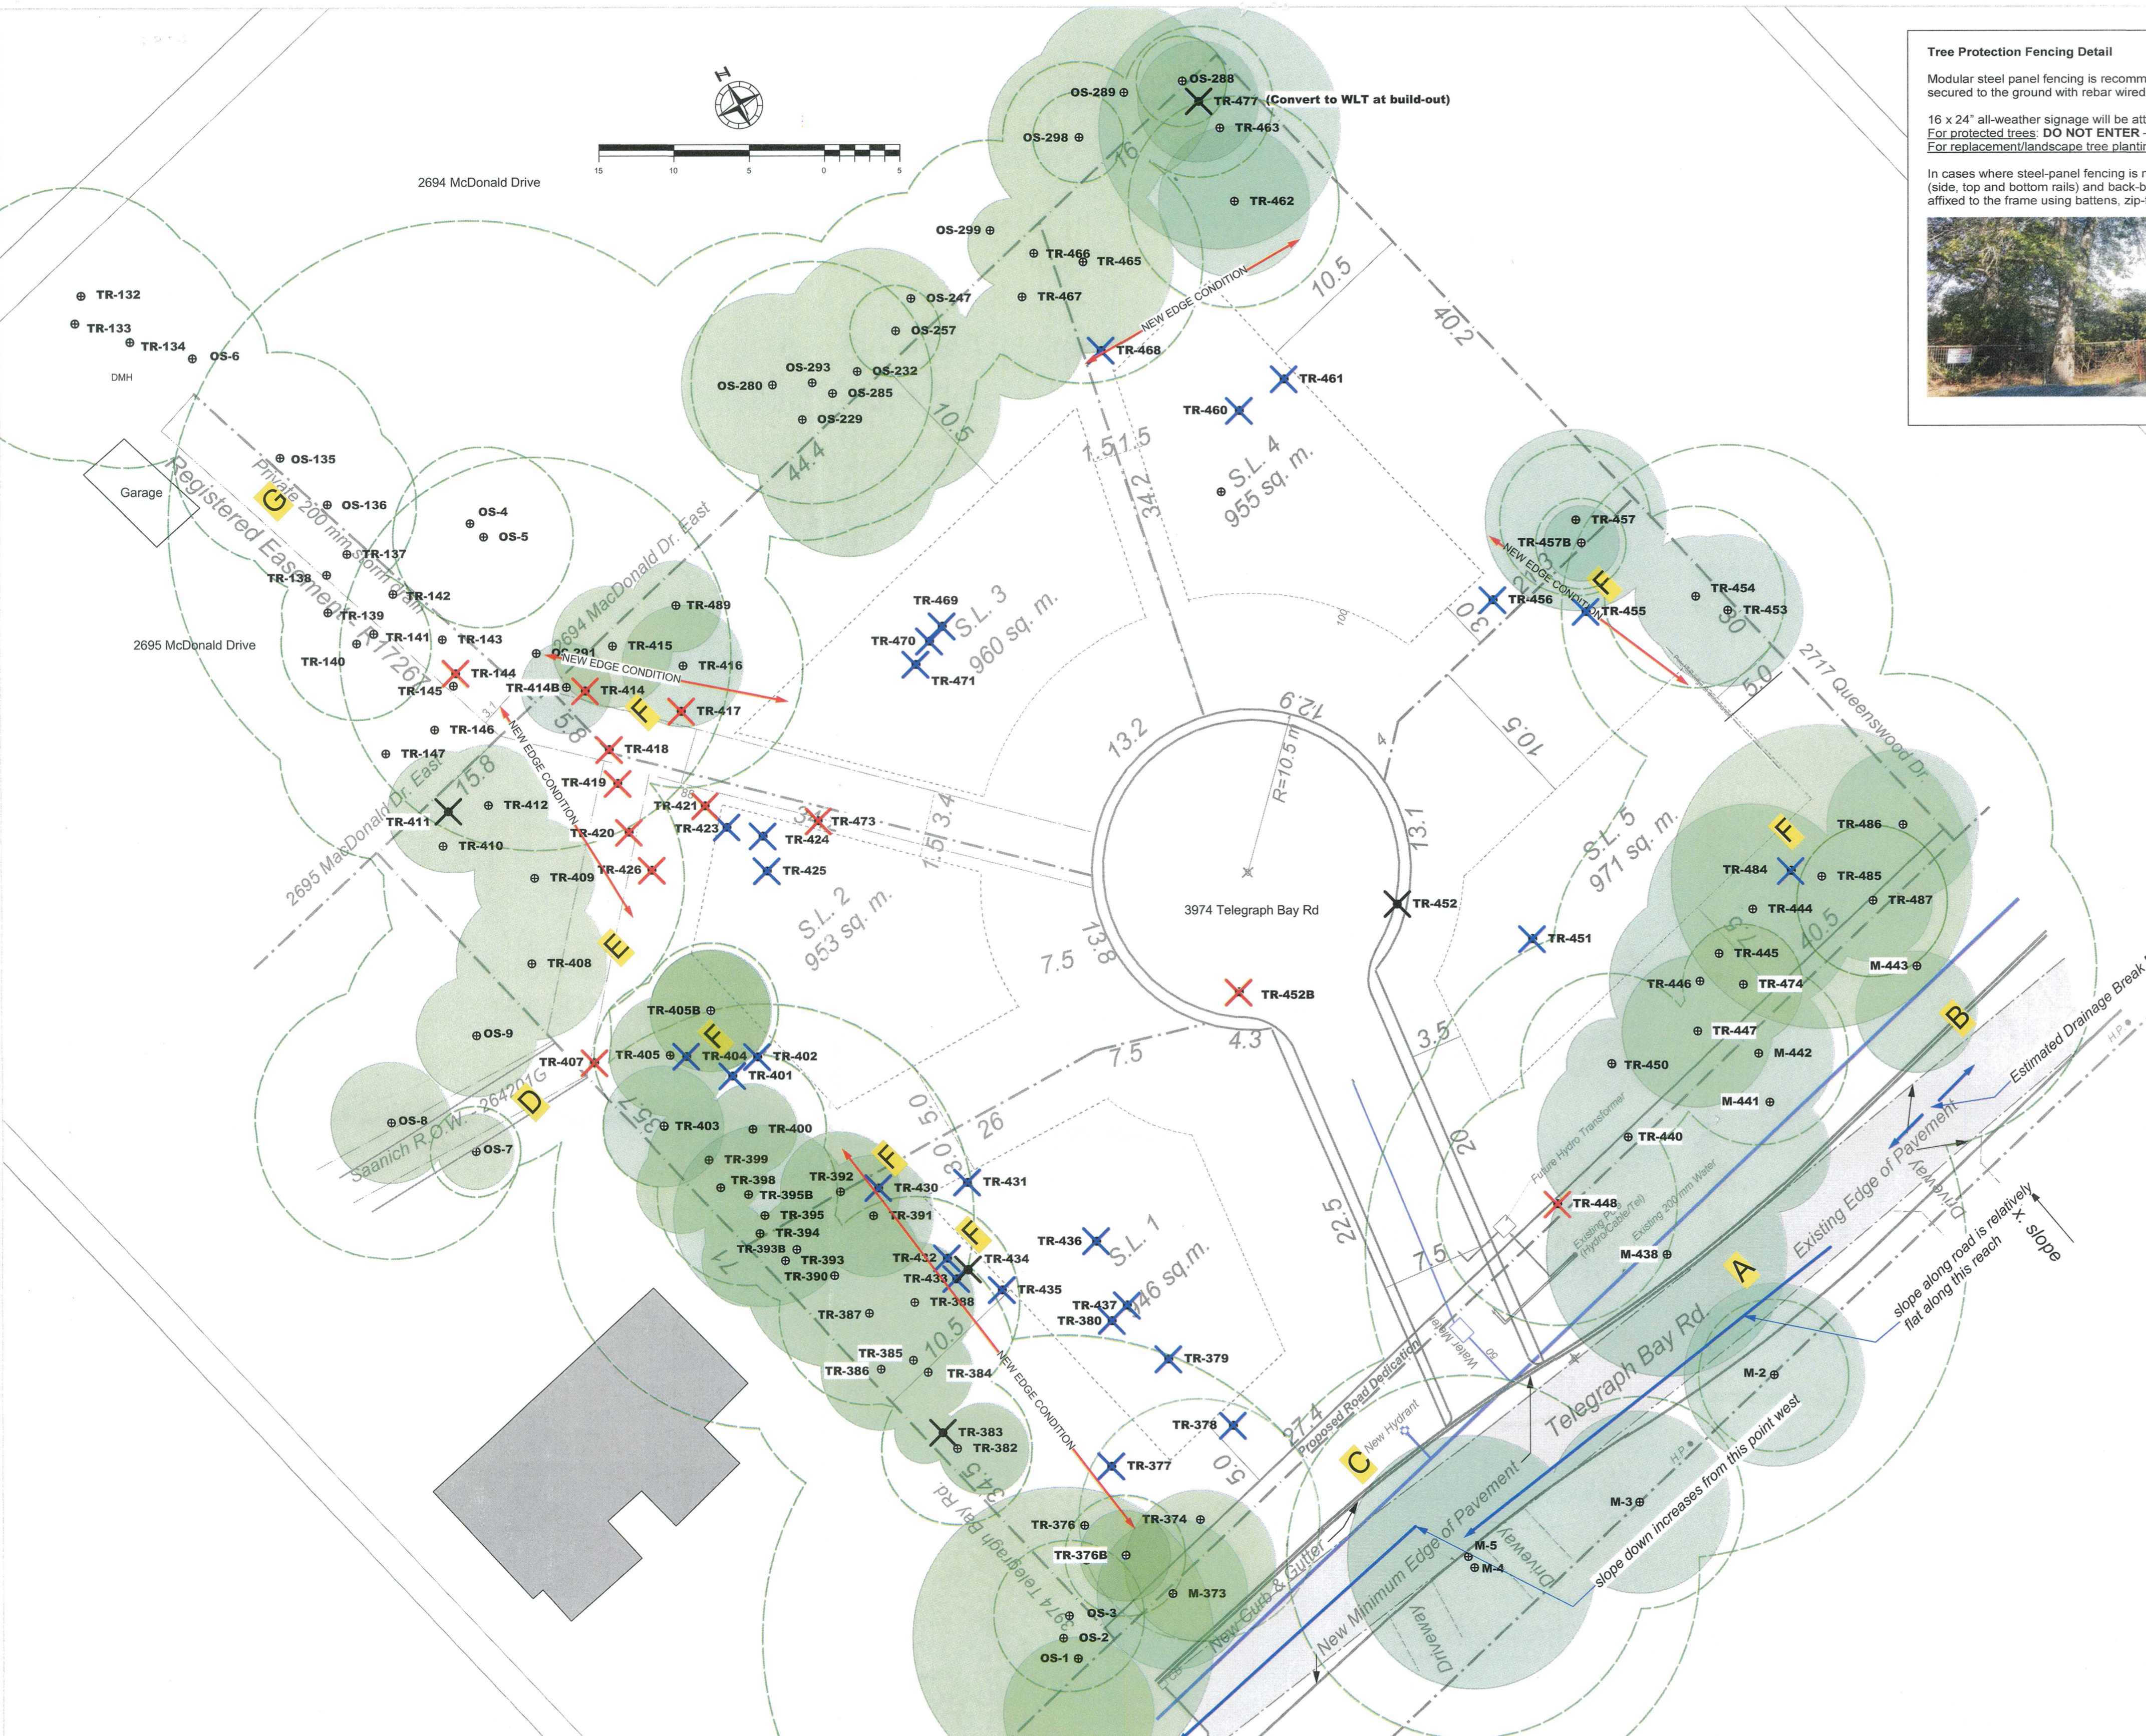
### EXPLANATORY PLAN NOTES AND KEY

**A.** Subgrade preparation for road widening on both sides of Telegraph Bay road intrudes into the root zones of protected trees. It is recommended that the road not be widened in order to avoid significant impacts to the root systems of the affected trees. Failing this, efforts should be made to design the new road to bridge over the top of the tree root horizon and construct it using low-impact best practices under the supervision of the project arborist. Best practices include exploratory work to confirm sub-surface root elevations to inform design, supervised subgrade excavation, hydro-excavation where required by the project arborist, retain and augment existing roadbase.

**B.** Proposed Curb & Gutter Recommended for deletion adjacent to tree root zones by project arborist (see Aug 16th 2023 letter-report)

**C.** New hydrant and water connection shall be hydro-excavated under the supervision of the project arborist.

**D.** Off-site servicing works shall supervised by the project arborist. Low-impact best practices shall be employed to minimize root impacts to adjacent trees and large shrubs, including use of rubber-tracked mini-excavator, soil armoring and root pruning.

**E.** Servicing works shall supervised by the project arborist. Low-impact best practices shall be employed to minimize root impacts to adjacent trees.

**F.** Tree stumps located within the PRZ of protected trees shall be routed out with a stump chipper.

**G.** The drain service through this easement shall be excavated under the direct supervision of the project arborist. Low-impact best practices shall be employed to minimize root impacts to adjacent trees including use of rubber-tracked mini-excavator, hand-digging, hydro-excavation, soil armoring and root pruning. (See June 27th, 2023 Work Plan Report.)

- Tree Fencing:**
    - Tree protection fencing shall be installed to the District of Saanich standards at the locations indicated on this drawing prior to conditional approval being given (see fencing detail on plan).

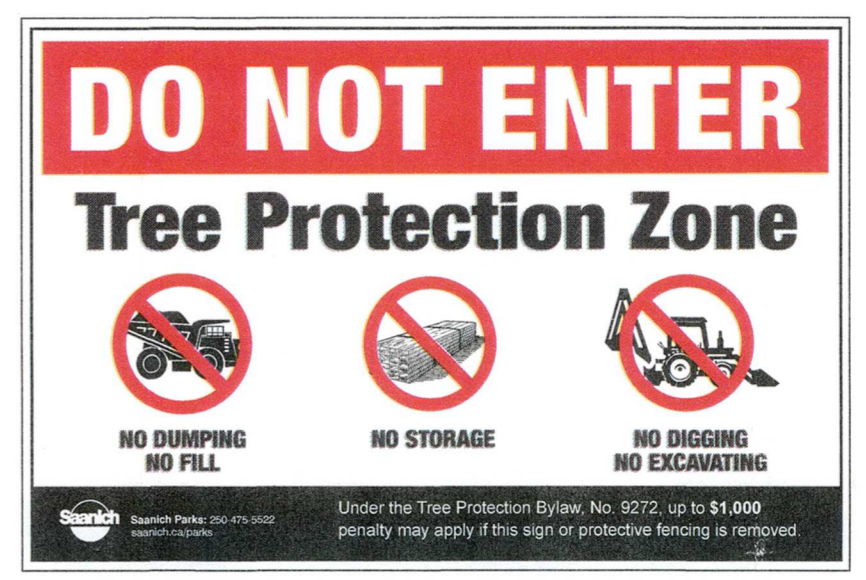
#### TREE PROTECTION FENCING SIGNAGE

(Signs shall be 16x24" and made to sustain all weather conditions)
